Situation Photo Log

Monday, March 5, 2012

Kalamazoo River / Enbridge Spill

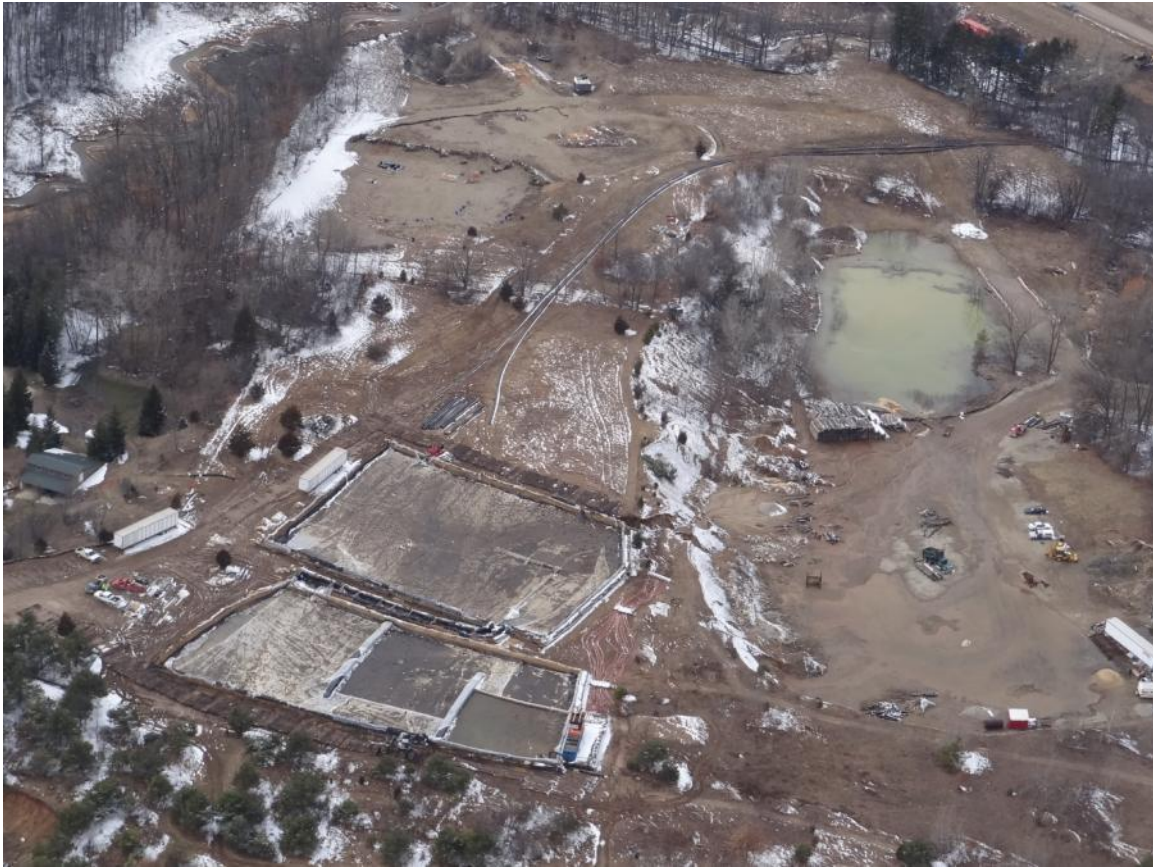
1. Turbidity Control Structure empty.

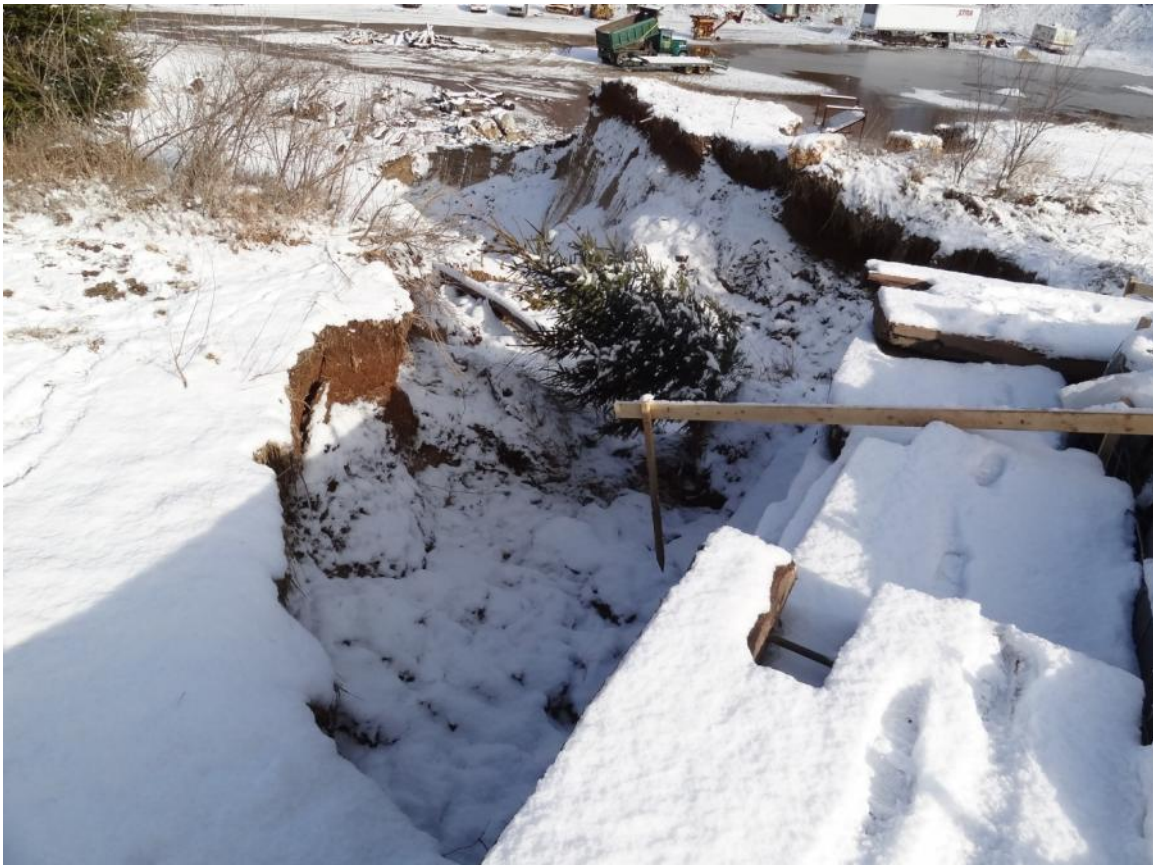
2. Turbidity Control Structure erosion caused by the structure failure on Saturday.

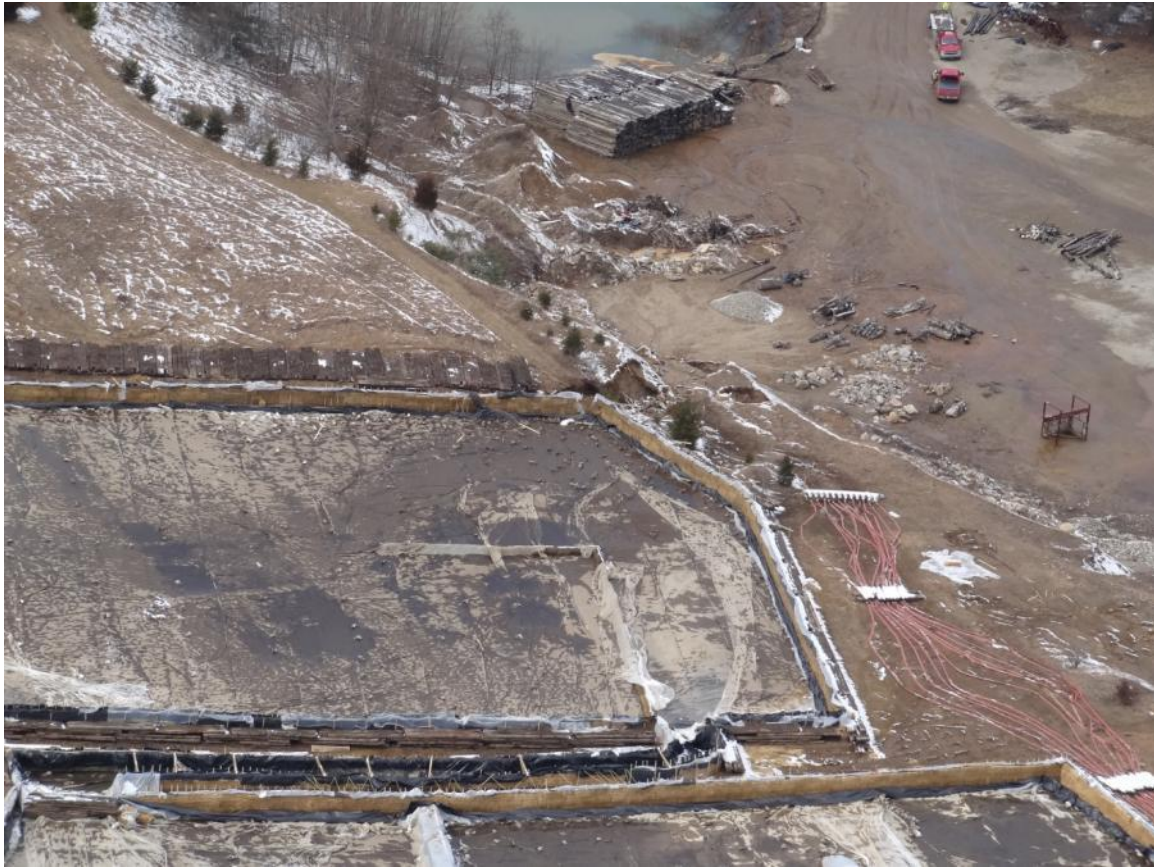
3. Turbidity Control Structure erosion caused by the structure failure on Saturday.

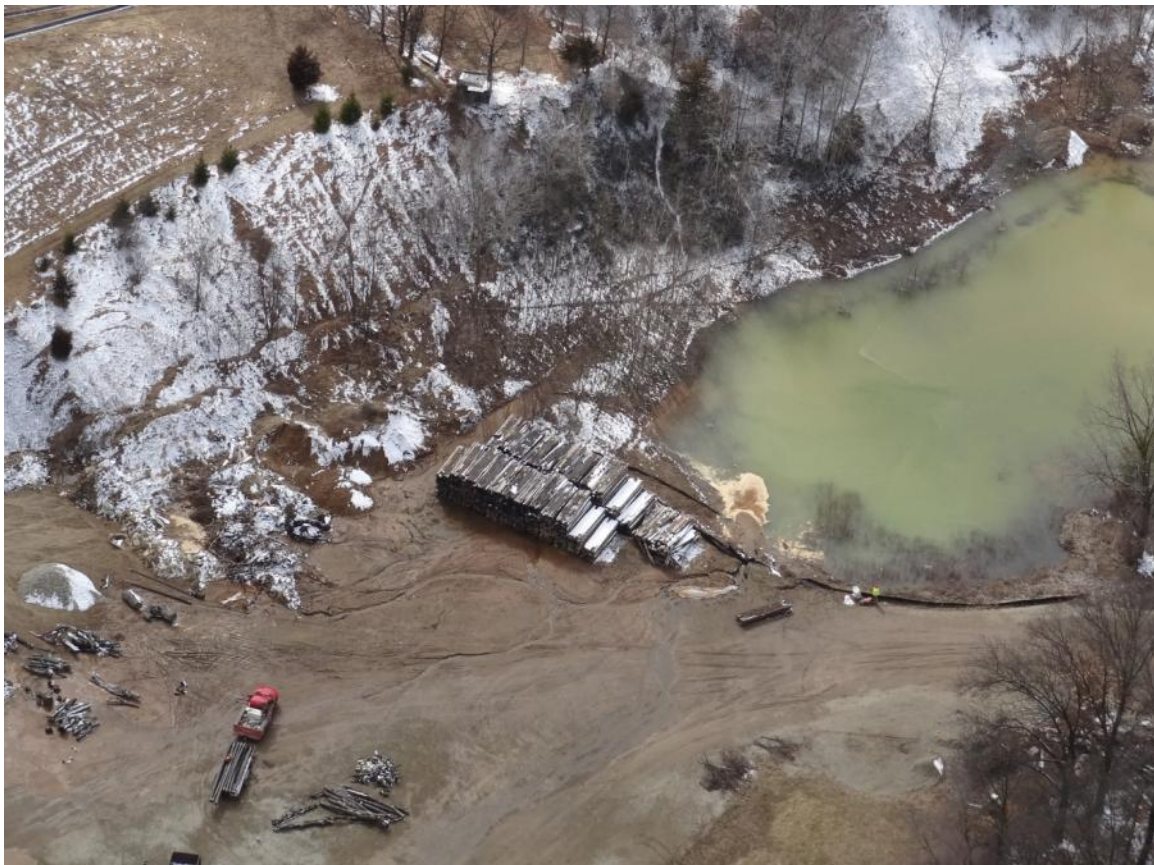
4. Flooded pond in rock quarry from the failure of Turbidity Control Structure on Saturday.

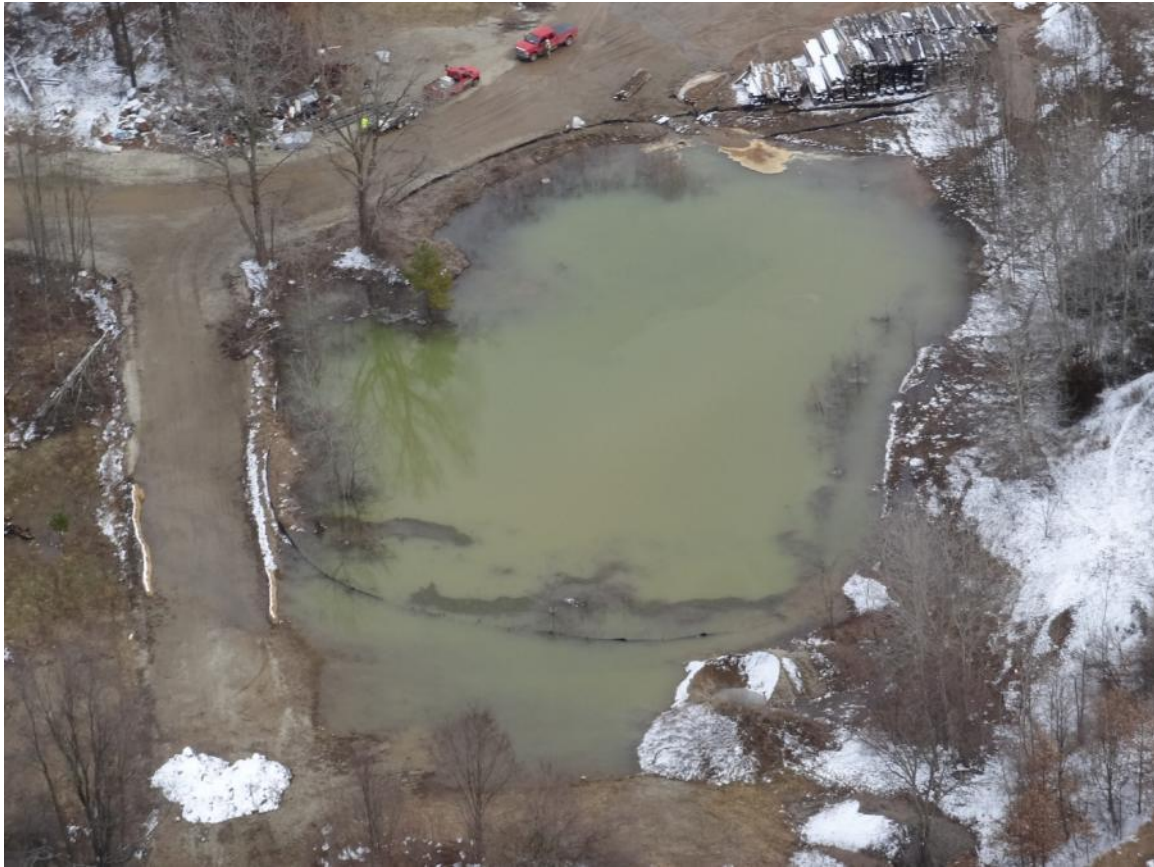
5. Flooded pond in rock quarry from the failure of Turbidity Control Structure on Saturday.

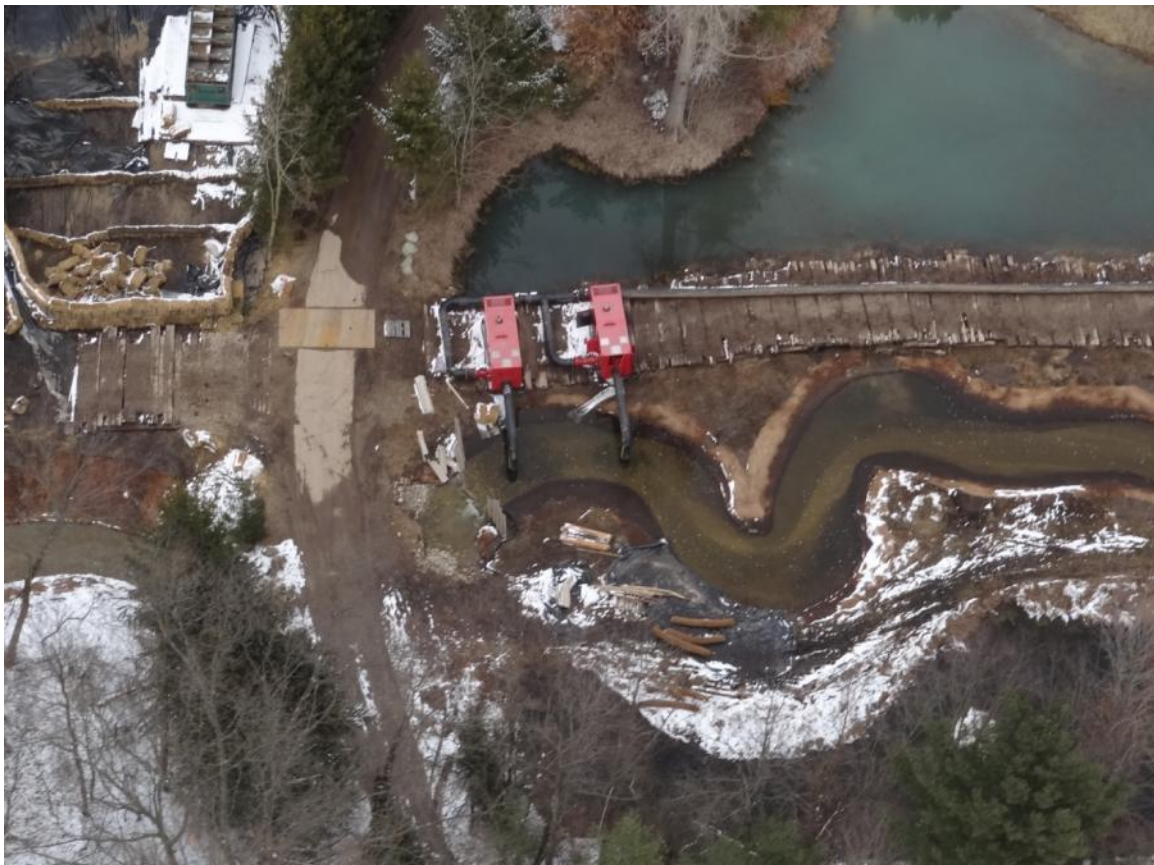
6. Talmadge Creek bypass open near MP1.6.

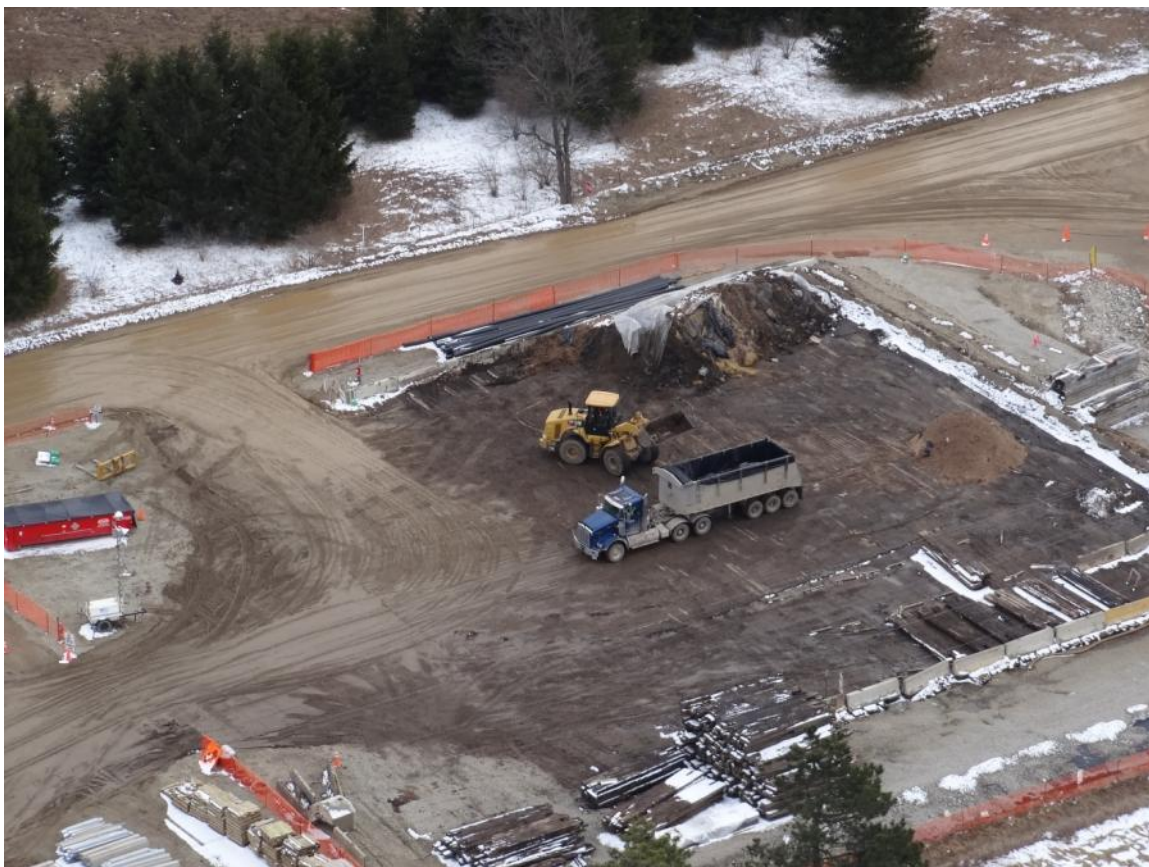
7. Frac-City Soil Cells A & B observed soils being loaded for disposal off site.

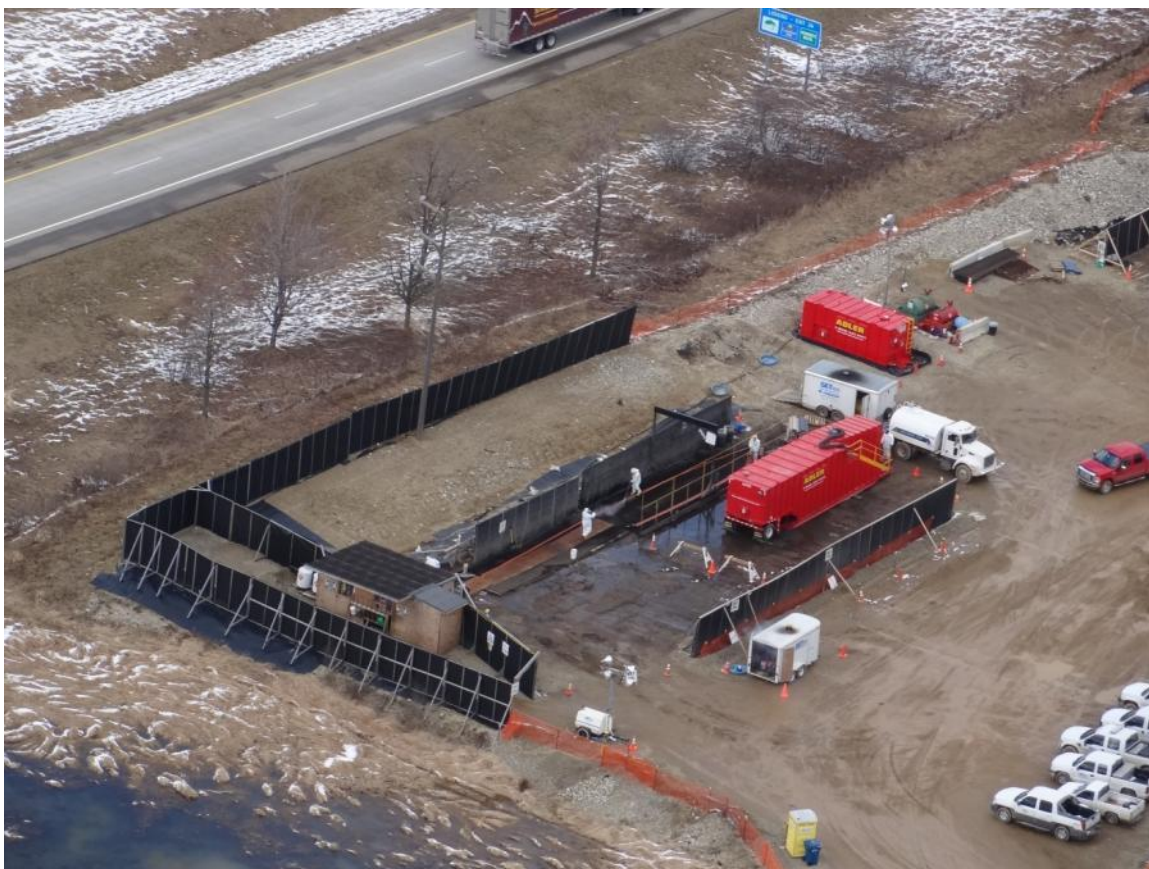
8. Frac-City observed crews decontaminating hose and a frac-tank.

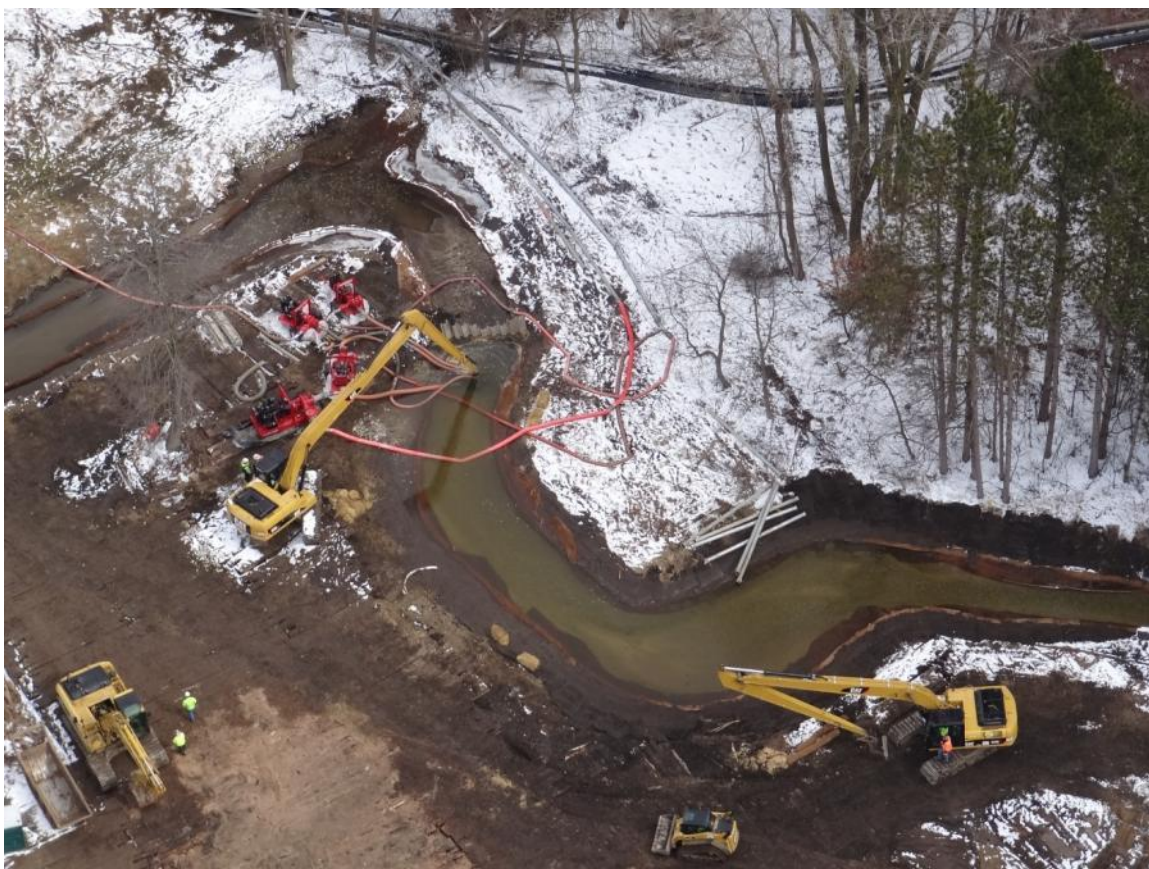
10. Talmadge Creek near MP1.9 observed crews installing dewatering pumps.

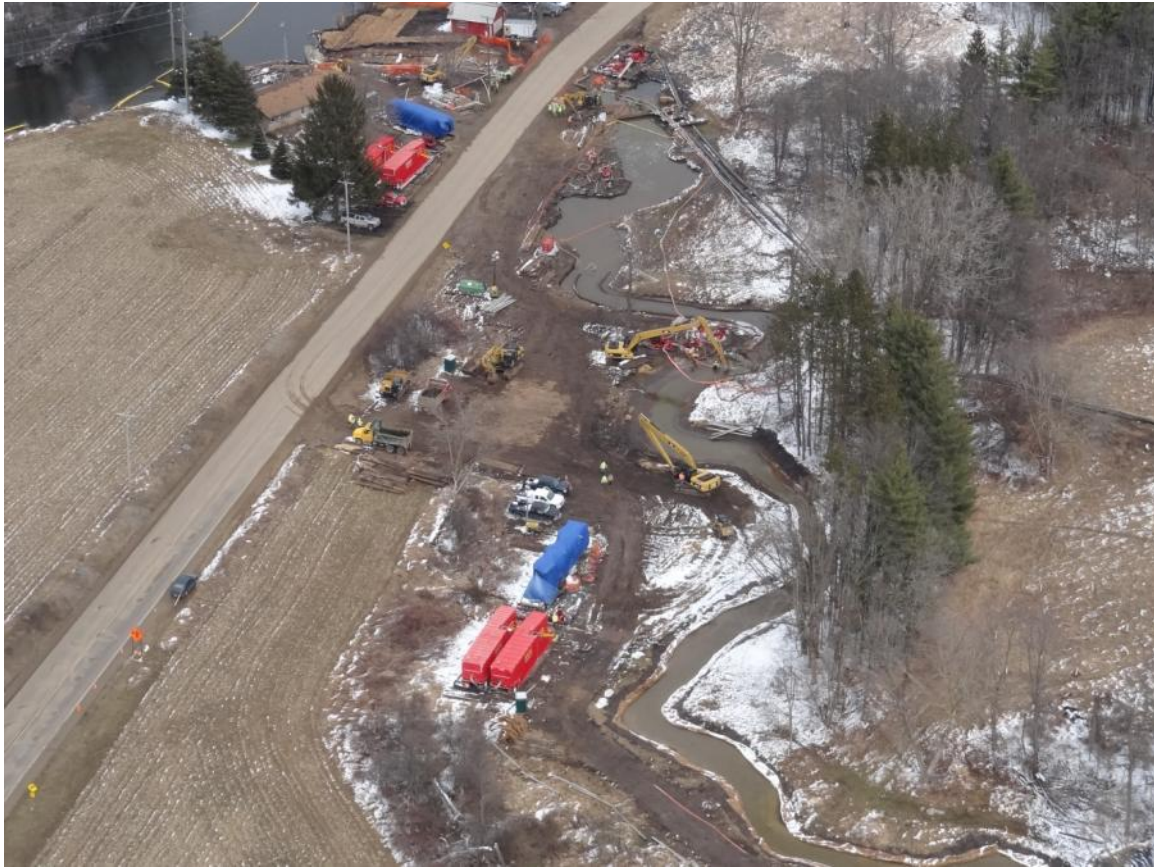
11. Talmadge Creek near MP1.9 observed crews installing dewatering pumps.

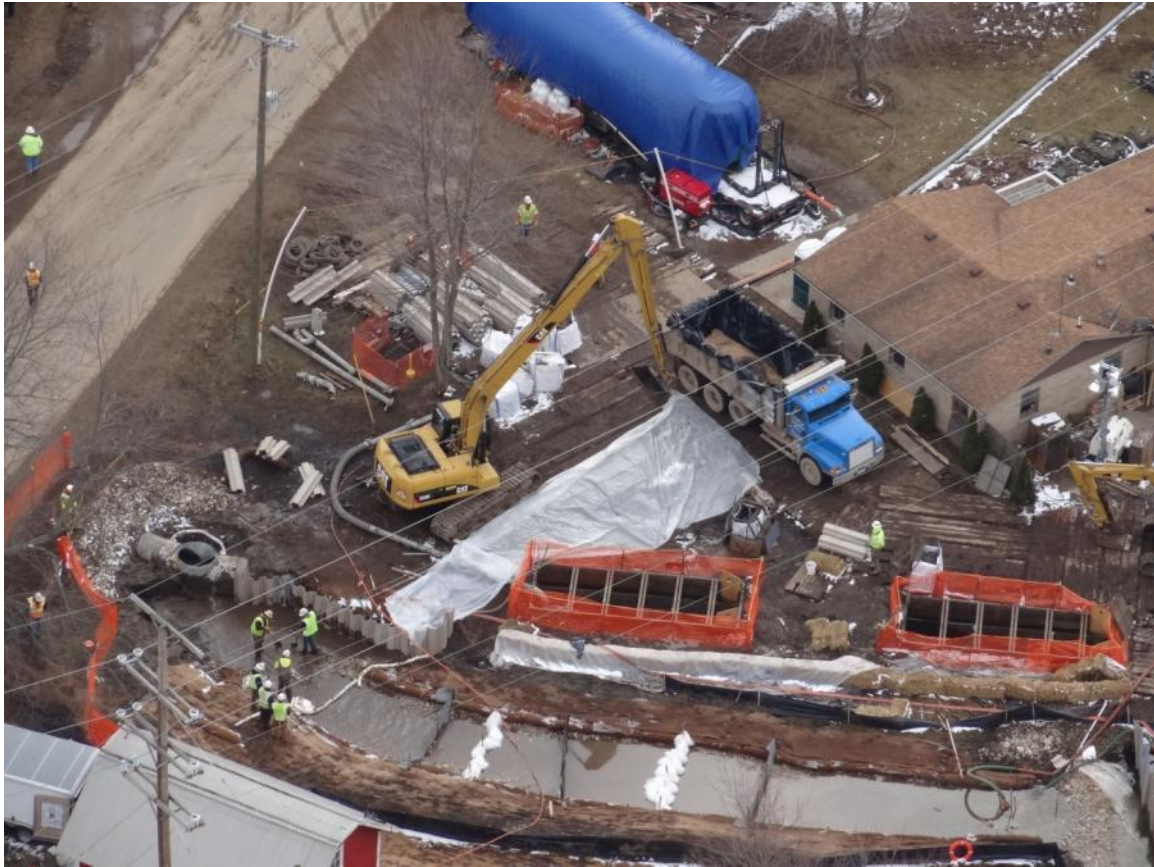
15. Creek portion of Confluence, observed crews preparing to unhook the bypass.

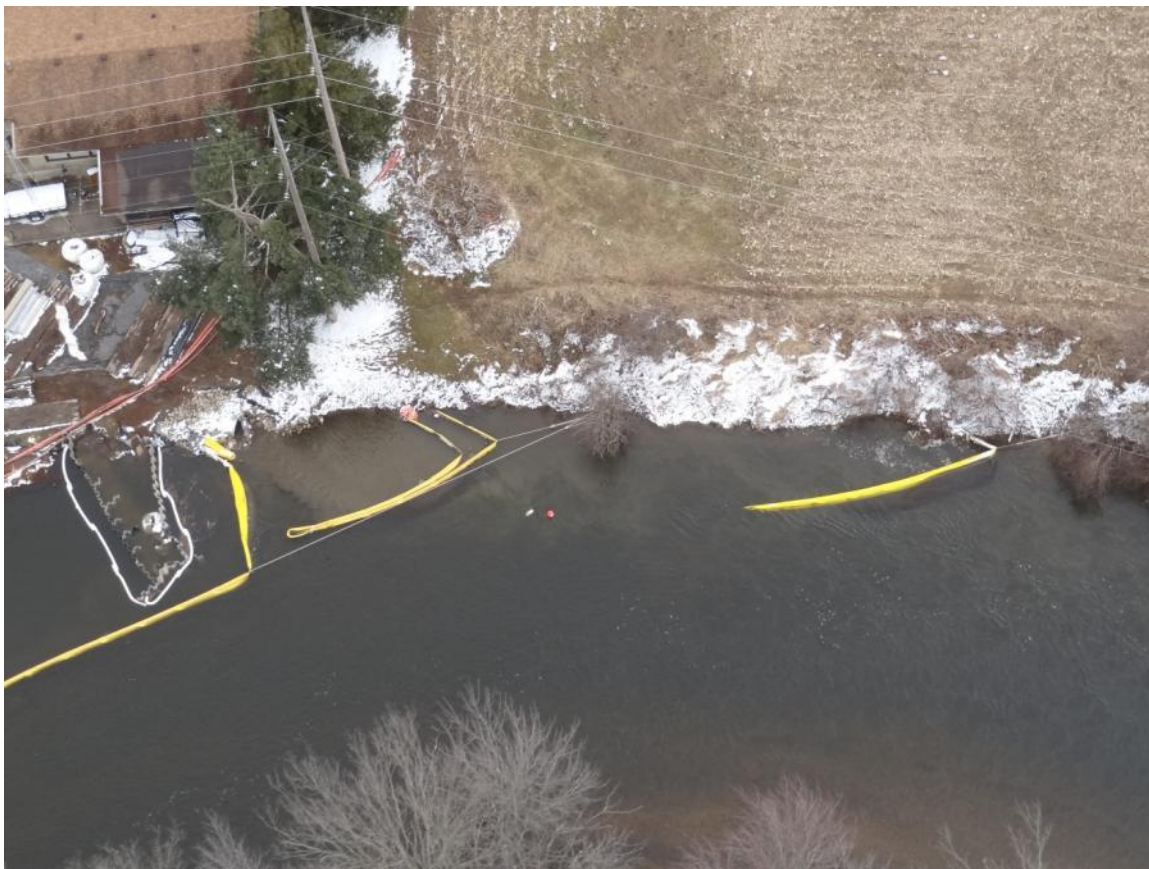
18. Turbidity observed at the Confluence.

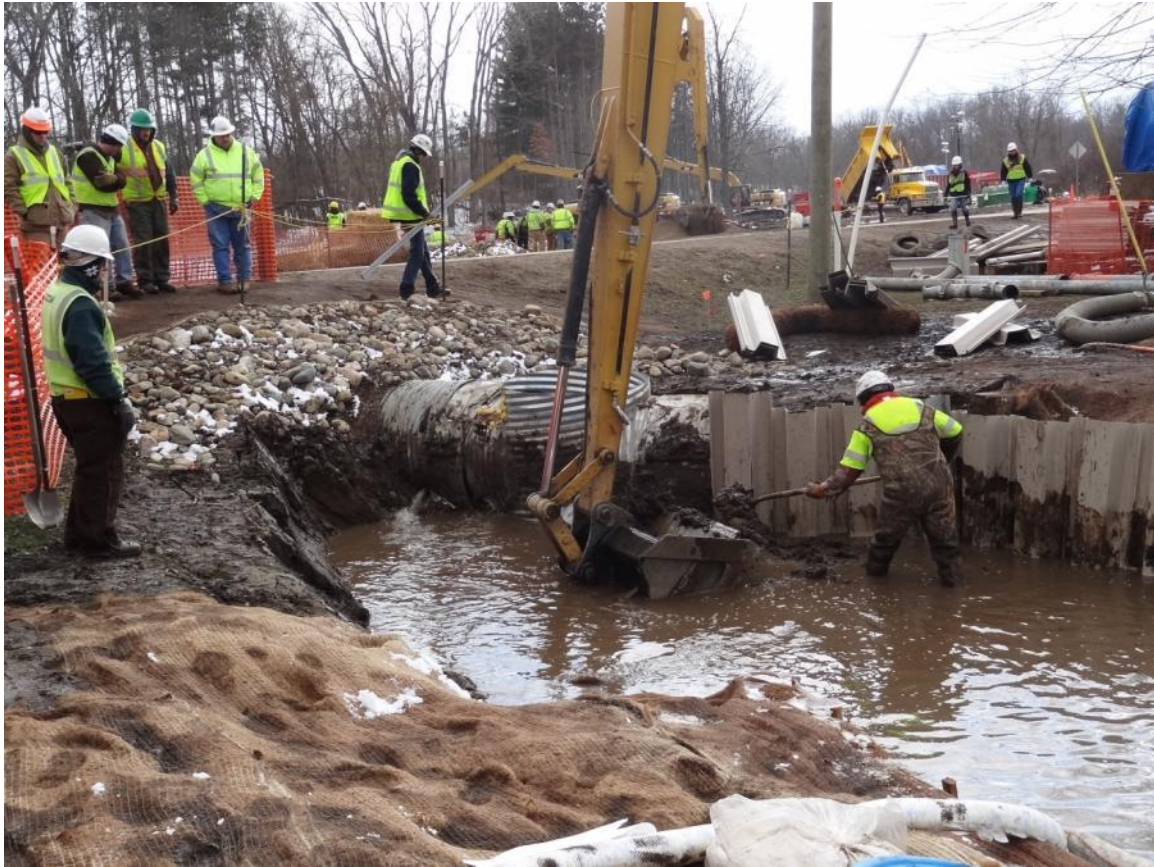
19. Talmadge Creek: Crews excavating to detach the bypass.

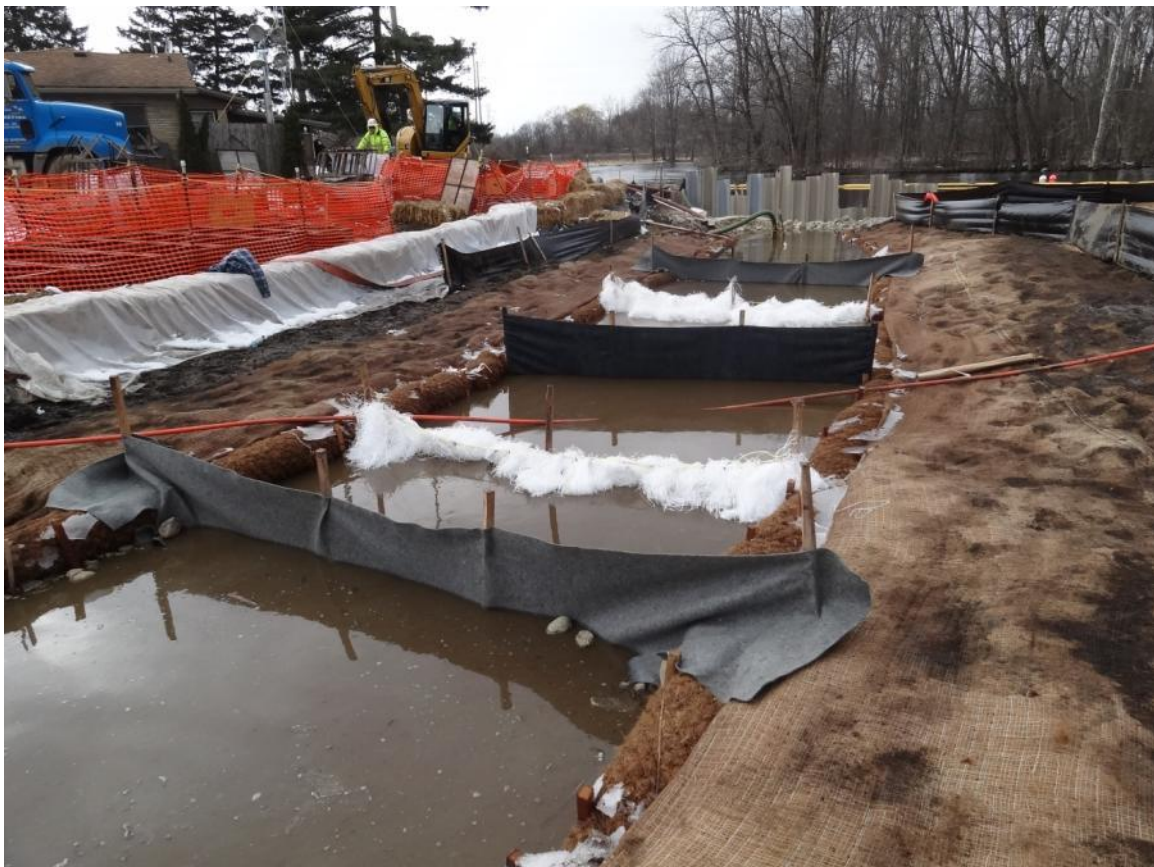
20. Turbidity control within creek portion of the Confluence.

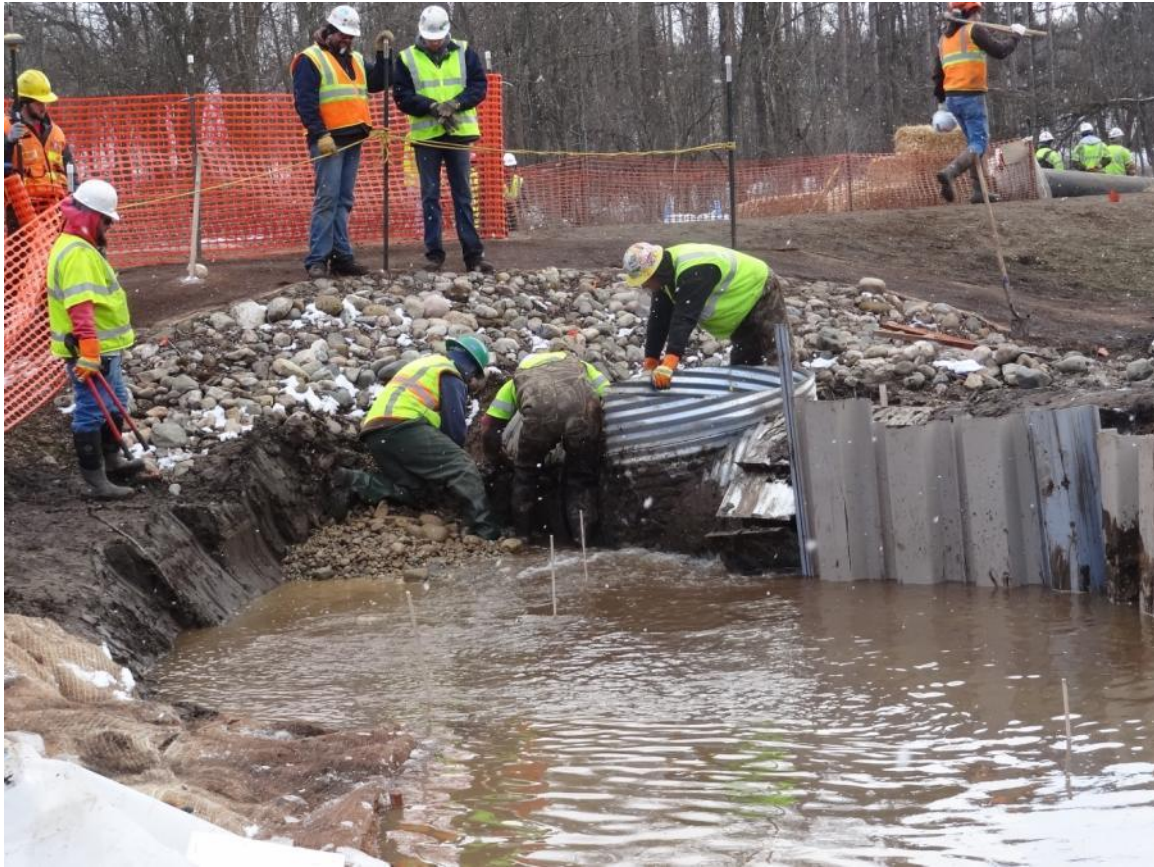
21. Crews detaching bypass pipe from culvert at A Drive.

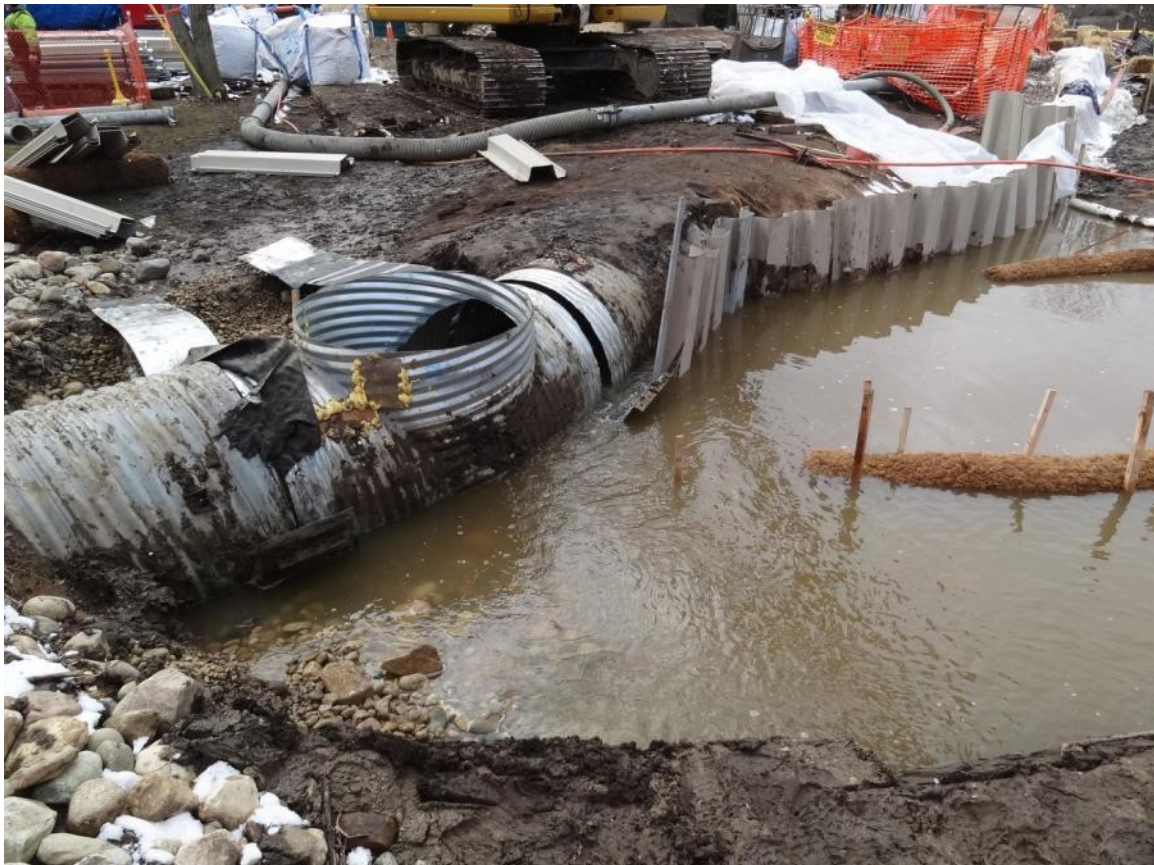
22. Crews detaching bypass pipe from culvert at A Drive.

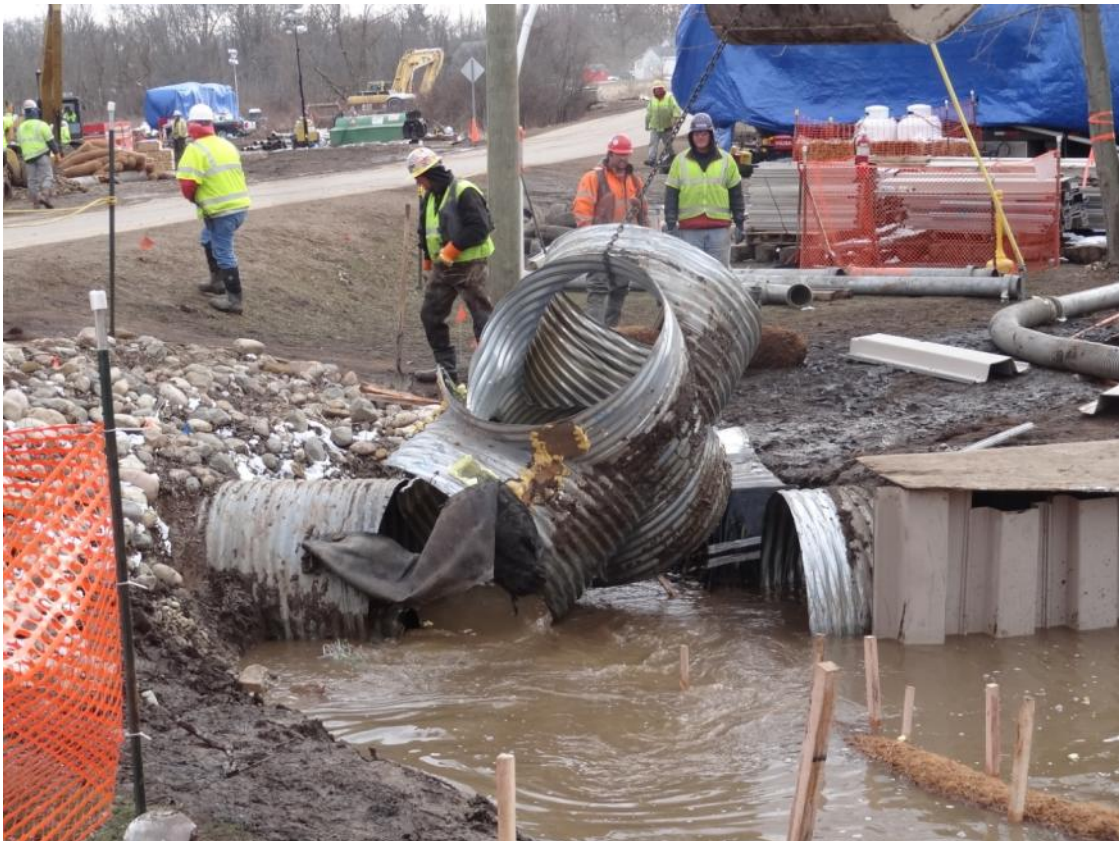
24. Crews detaching the bypass from culvert.

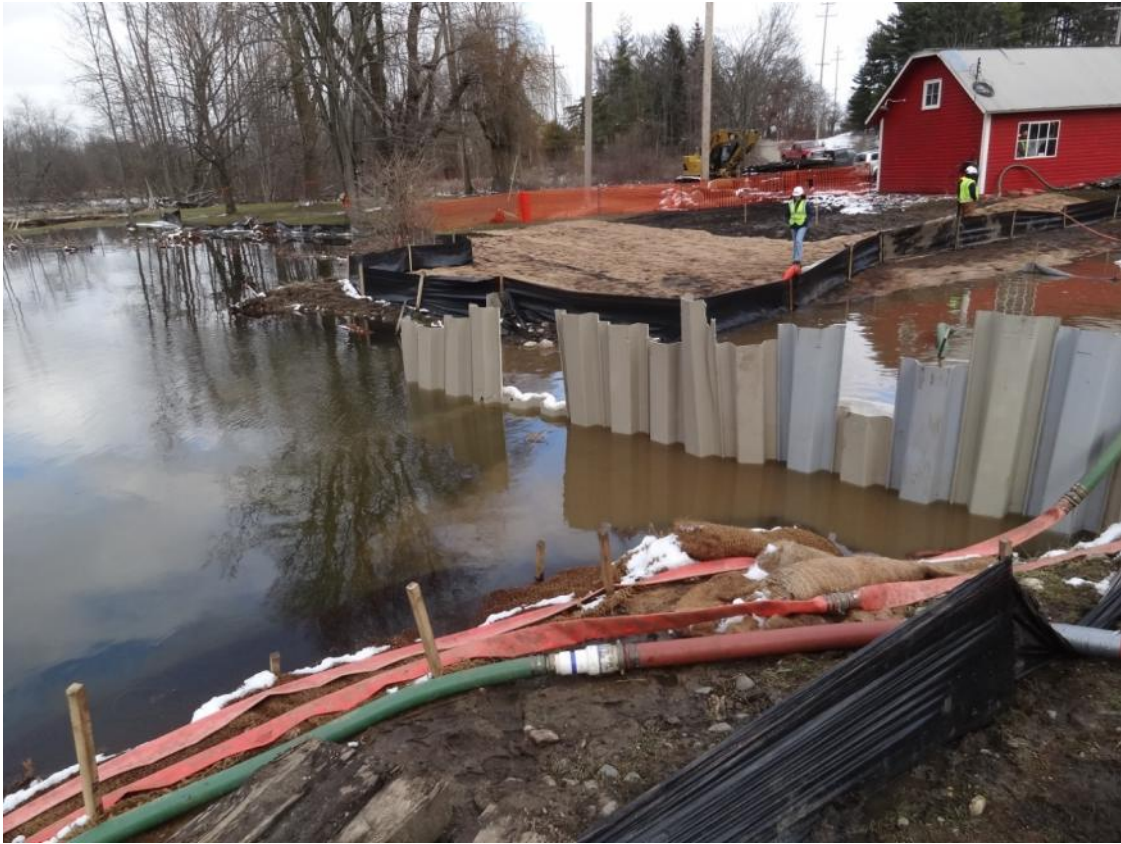
25. Observed turbidity entering confluence.

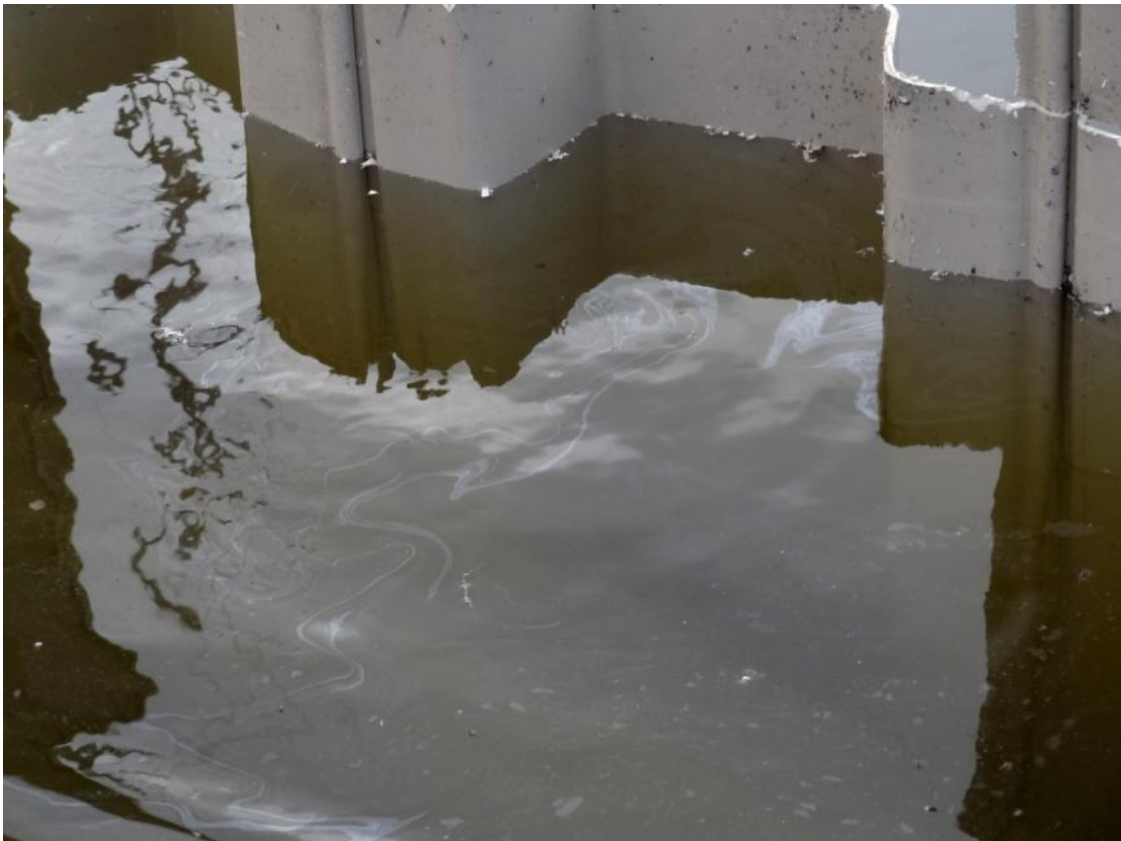
26. Sheen observed and sheet piling prior to the confluence.

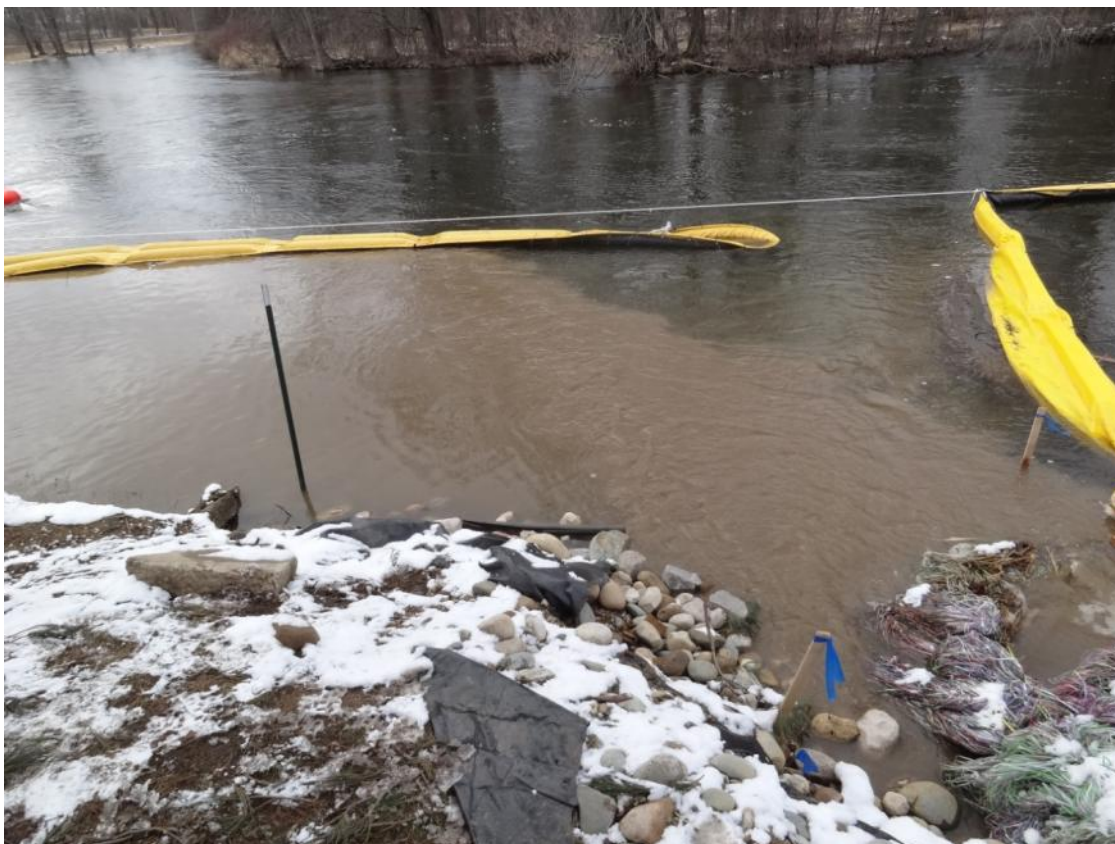
27. Observed turbidity at bypass discharge.

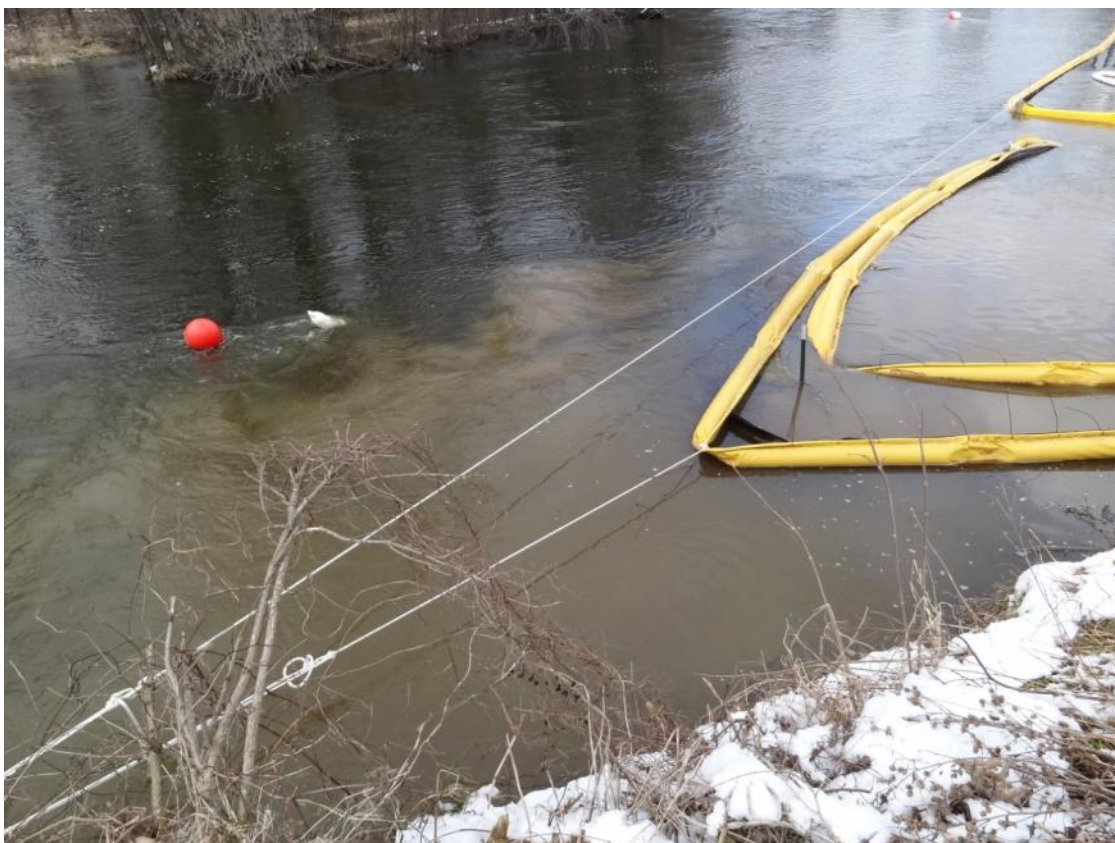
28. Observed turbidity at bypass discharge.

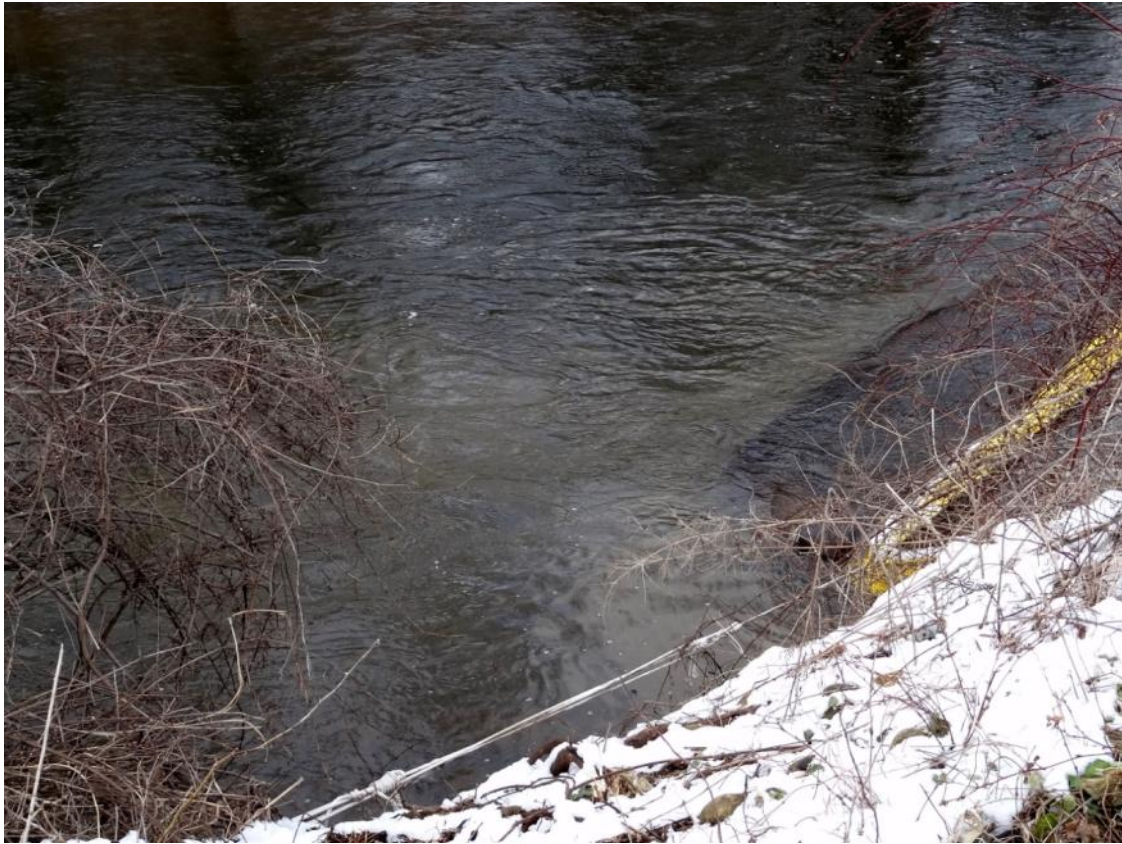
29. Observed turbidity pass last check mark.

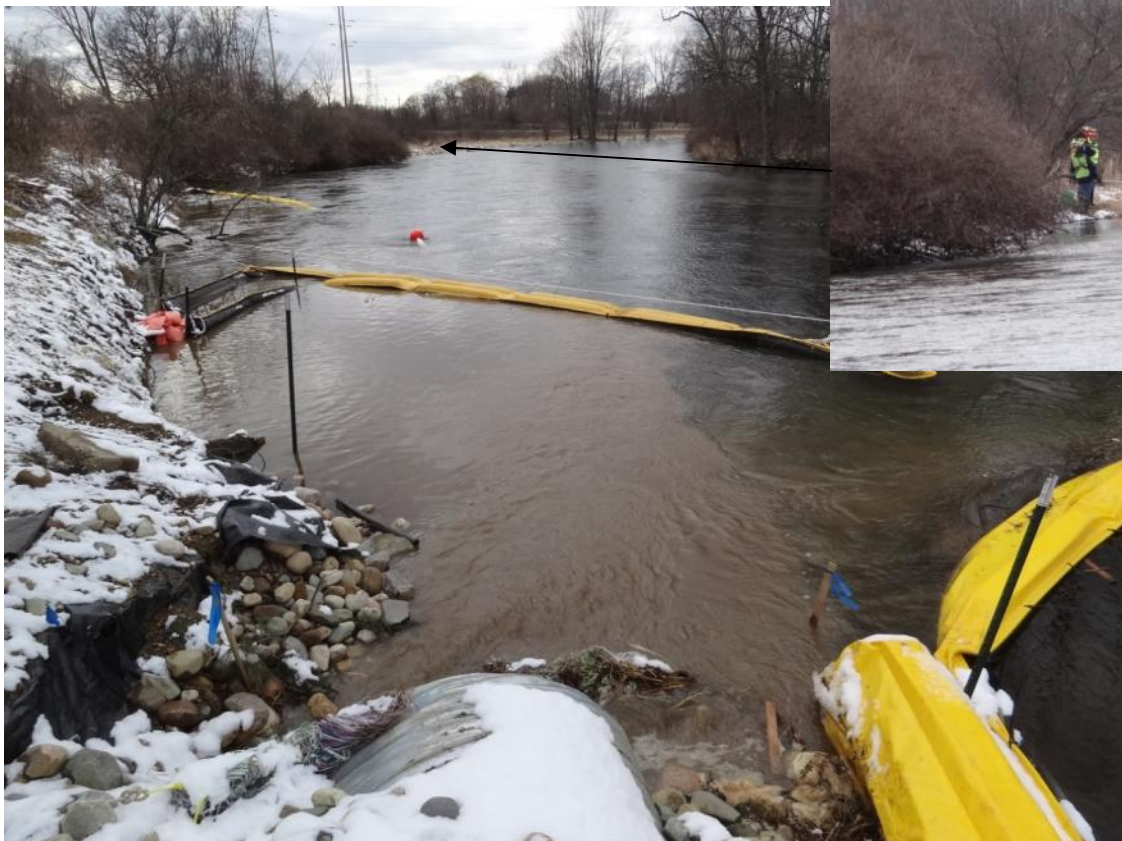
30. 300' Down river where trigger point is for turbidity.
